# DAMAGE ASSESSMENT FORM

Building Name PALM LODGE

Address 17390 SW 296 STREET

City (or Vicinity) and County DADE COUNTY, MIAMI, FL

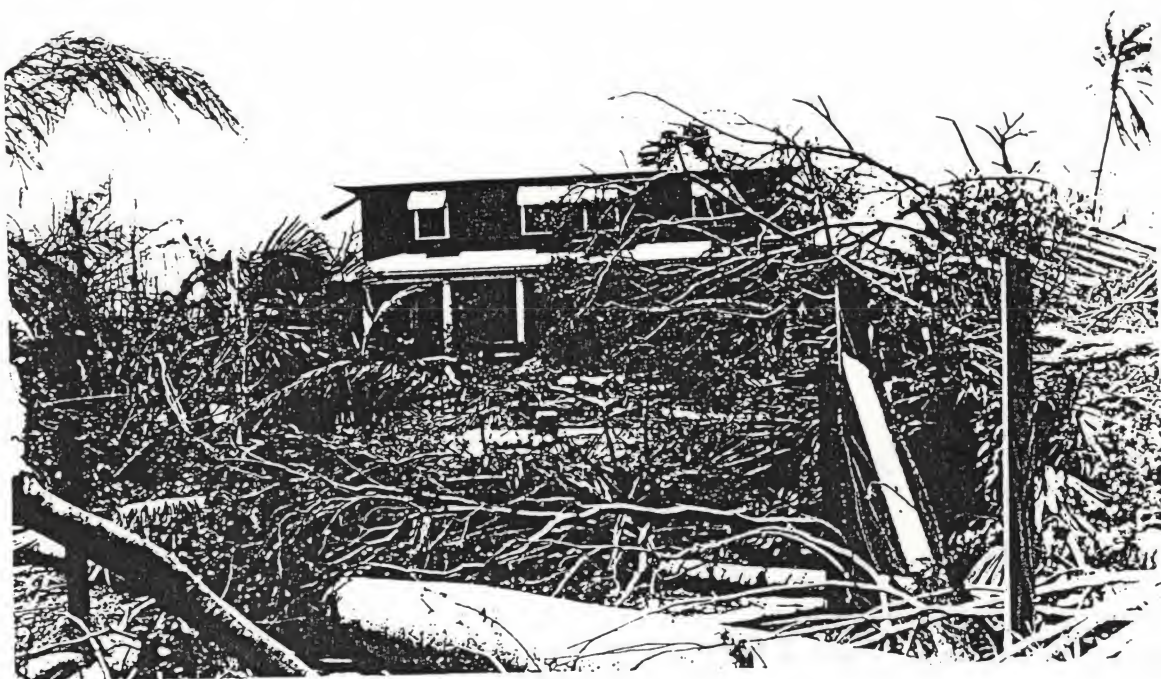
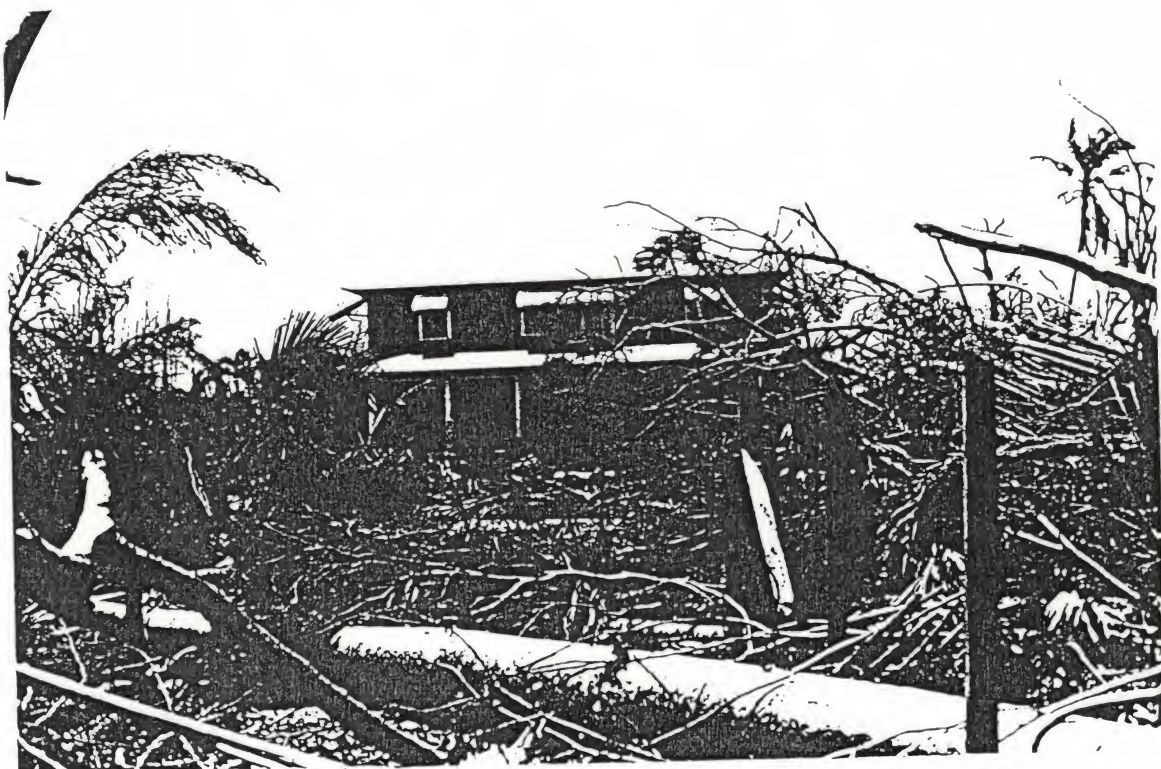
PALM LODGE

%	Comments
Exterior Walls	<u>1</u>	
Frame (General Condition)	<u>20</u>	
Frame Members	<u>20</u>	<u>&amp; 2nd Floor damage from chimney</u>
Frame Connections	<u>10</u>	<u>falling through roof</u>
Roof Framing	<u>20</u>	<u>caves, rafters in 20%</u>
Roof Covering	<u>20</u>	<u>new tile in some places</u>
Foundation	<u>0</u>	
Chimney(s)	<u>50</u>	<u>Fell into House</u>
Doors	<u>10</u>	<u>mostly broken glass</u>
Windows and Shutters	<u>10</u>	
Porch	<u>0</u>	
Downspouts and Gutters	<u>NA</u>	
Interior Bearing/Shear Walls	<u>0</u>	
Partitions (Nonbearing)	<u>1</u>	<u>water damage</u>
Floor(s)	<u>1</u>	
Stair(s)	<u>0</u>	
Glass	<u>20</u>	
Mechanical Equipment	<u>NA</u>	
Electrical Equipment	<u>NA</u>	
Garden and Trees	<u>50</u>	
Fences and Garden Walls	<u>40</u>	
Walkways and Sidewalks	<u>20</u>	
Other: _____		
Total Damage	<u>20</u>

OWNER IS WORRIED THEY WON'T BE ABLE TO AFFORD TO REPLACE THE TIN SHINGLES

Recommendations for Immediate Actions MOST NECESSARY ACTION HAS BEEN TAKEN - ROOF NEEDS TO BE SEALED OFF

Recommendations for Future Repair Work ROOF, CEILINGS ON EAST SIDE OF HOUSE, ELECTRICAL, SOME WALL PANELS NEED REPLACING
